**Crouch and Roach Estuaries  
Site of Special Scientific Interest  
Essex**

**Supporting Information**

***A supplement to the notification document***

Issued by Natural England's Essex Local Delivery Team on **2 November 2017**

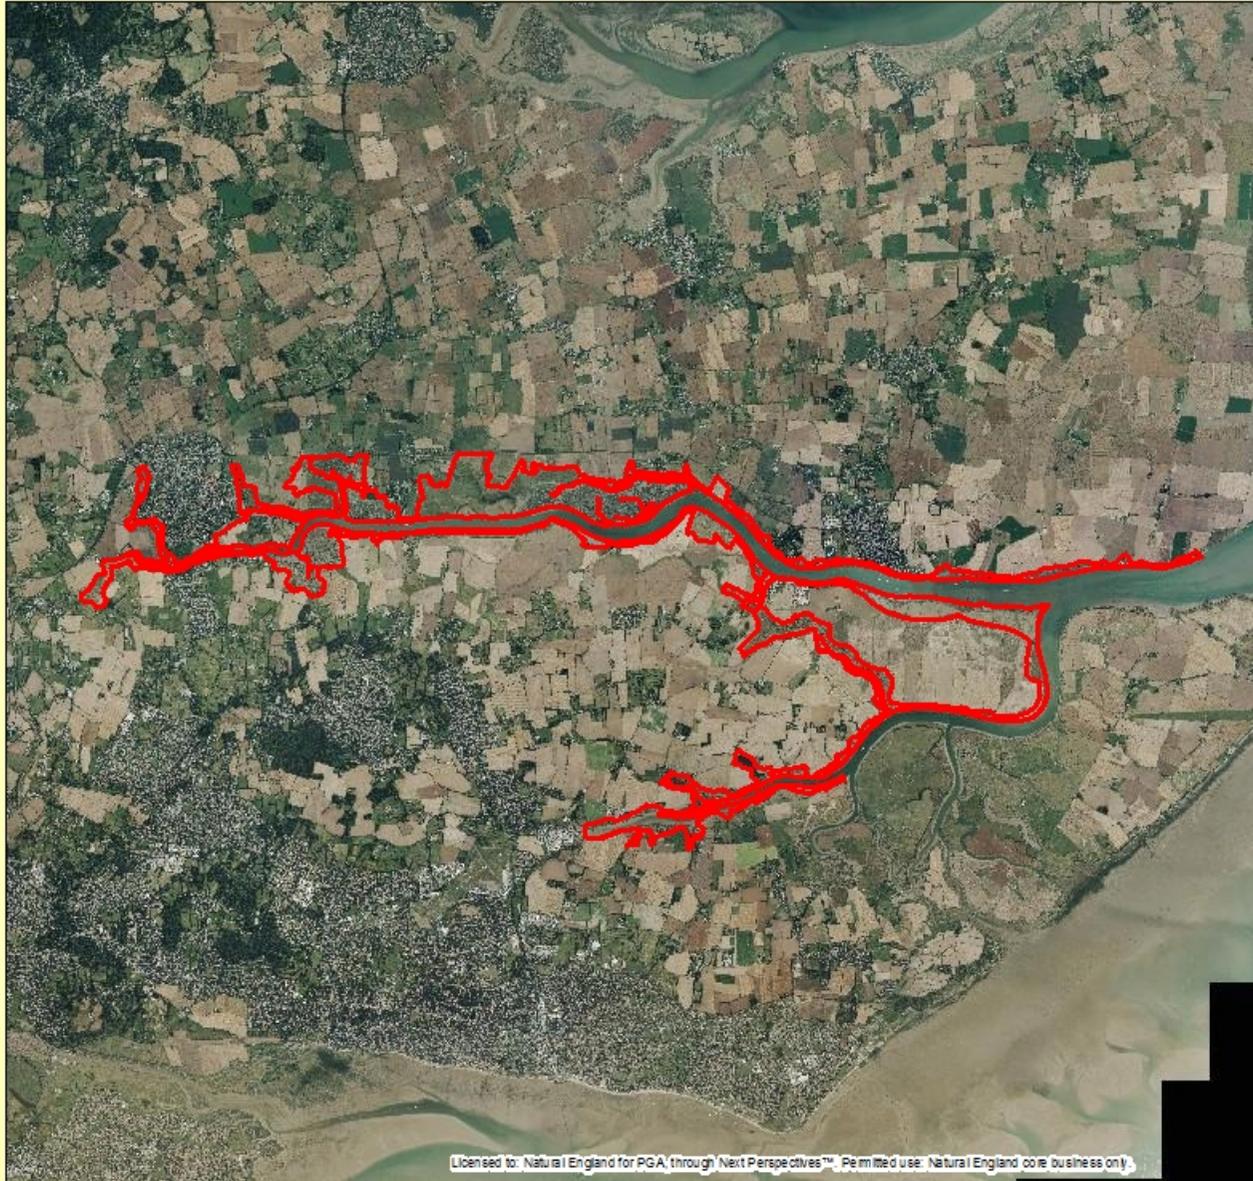
## **5. Site unit map**

The map on the following page shows the boundaries of the site units, which are divisions used by Natural England for administrative purposes only. The additional land is within units 59 (Brandy Hole) and 60 (Allfleet's Marsh, Wallasea Island).

The previously notified SSSI is divided into 58 site units, of which 16 are assessed as being in a 'favourable' condition, 41 are in 'unfavourable – recovering' condition and the remaining unit (55) is in 'unfavourable – no change' condition. The additional land is within site units 59 (Brandy Hole) and 60 (Allfleet's Marsh, Wallasea), the current condition of which is shown in table 2.

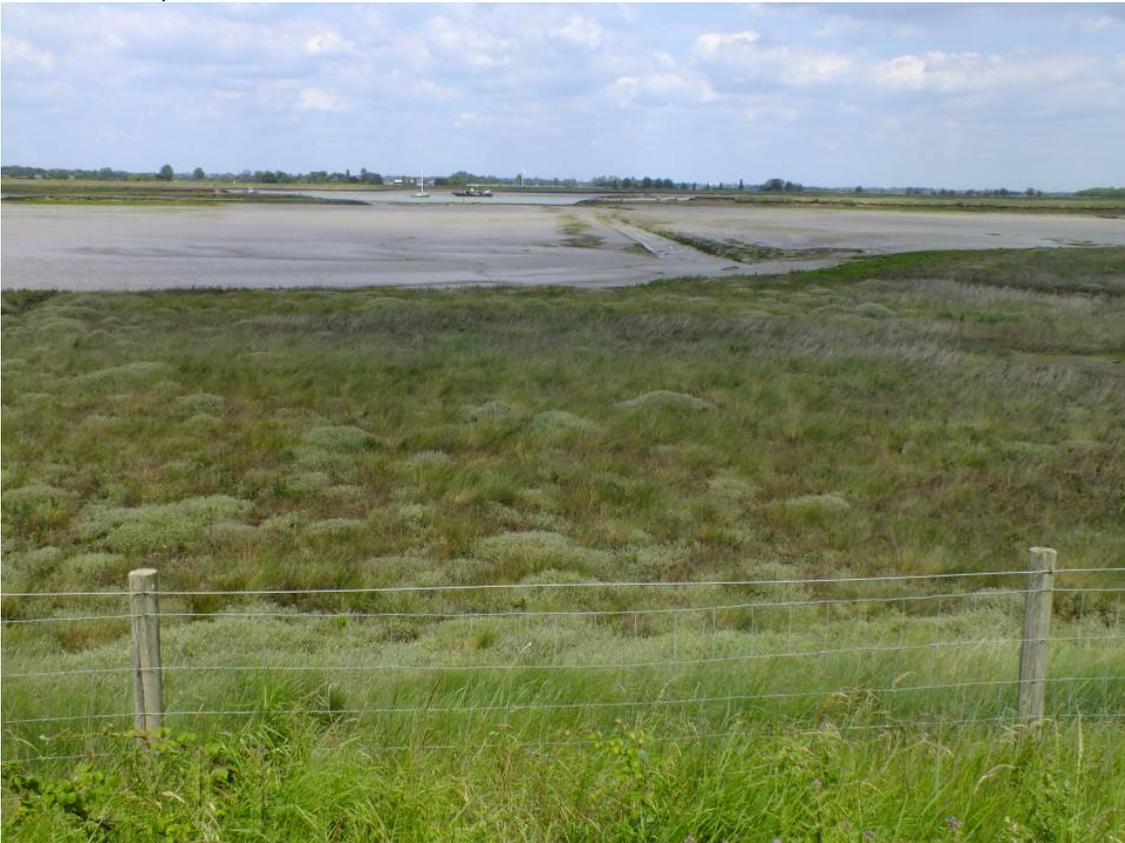
**Photo 2:** Central section of Allfleet's Marsh, Wallasea, looking north from new seawall at grid reference TQ96339446 across saltmarsh and mudflat to old, breached seawall (June 2015).

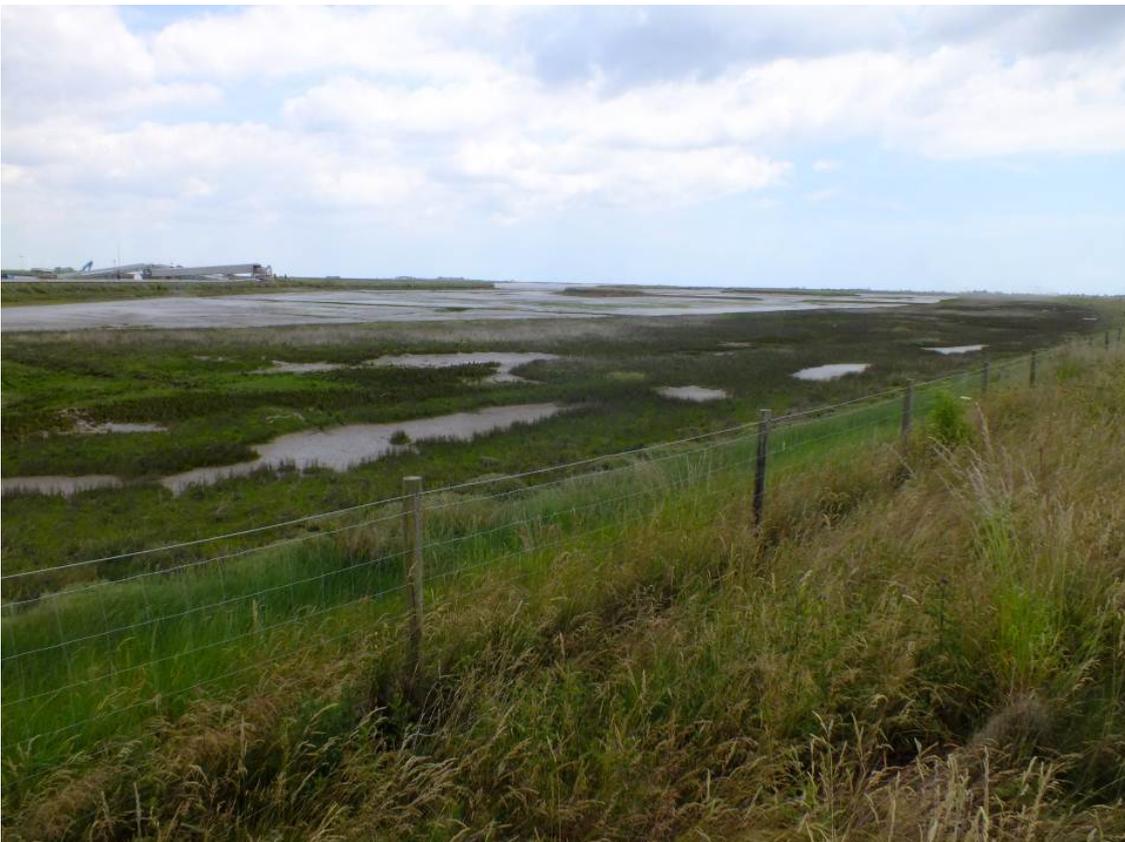
**Photo 3:** Eastern section of Allfleet's Marsh, Wallasea, looking north-east from new seawall at grid reference TQ96899448, across saltmarsh and mudflat to the old, breached seawall (June 2015).

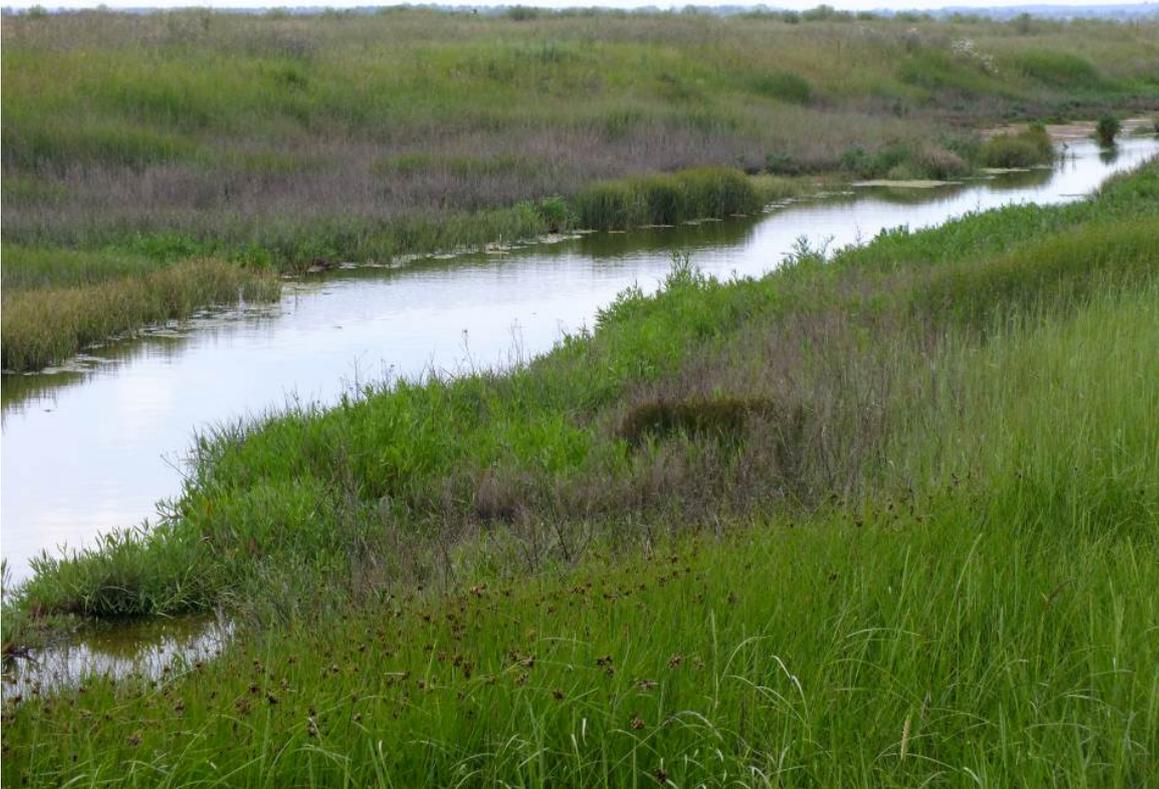
**Photo 4:** View west from grid reference TQ96429444 along the brackish borrow dyke behind the new seawall at Allfleet's Marsh, Wallasea, with emergent saltmarsh species (June 2015).

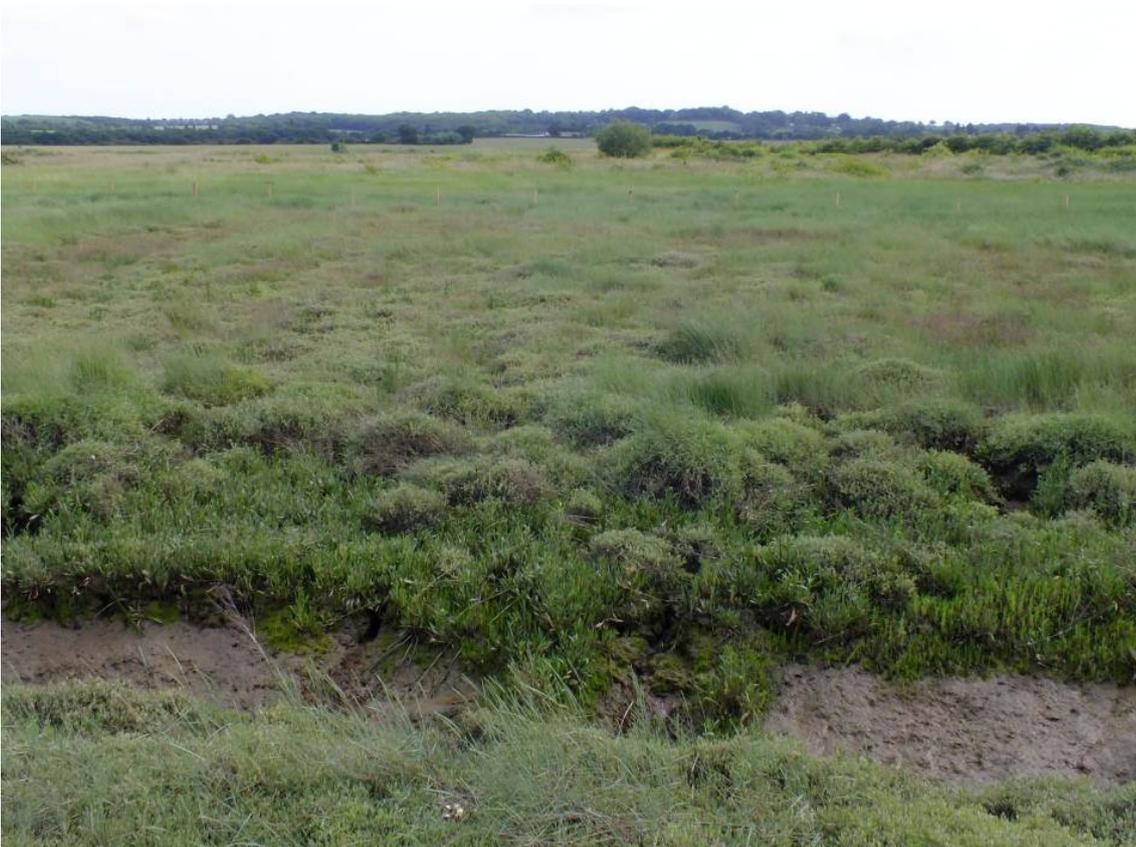
**Photo 5:** North part of Brandy Hole, looking south from old seawall at grid reference TQ83029558 across mid/upper saltmarsh to coarse grassland/scrub on rising ground beyond (June 2015).

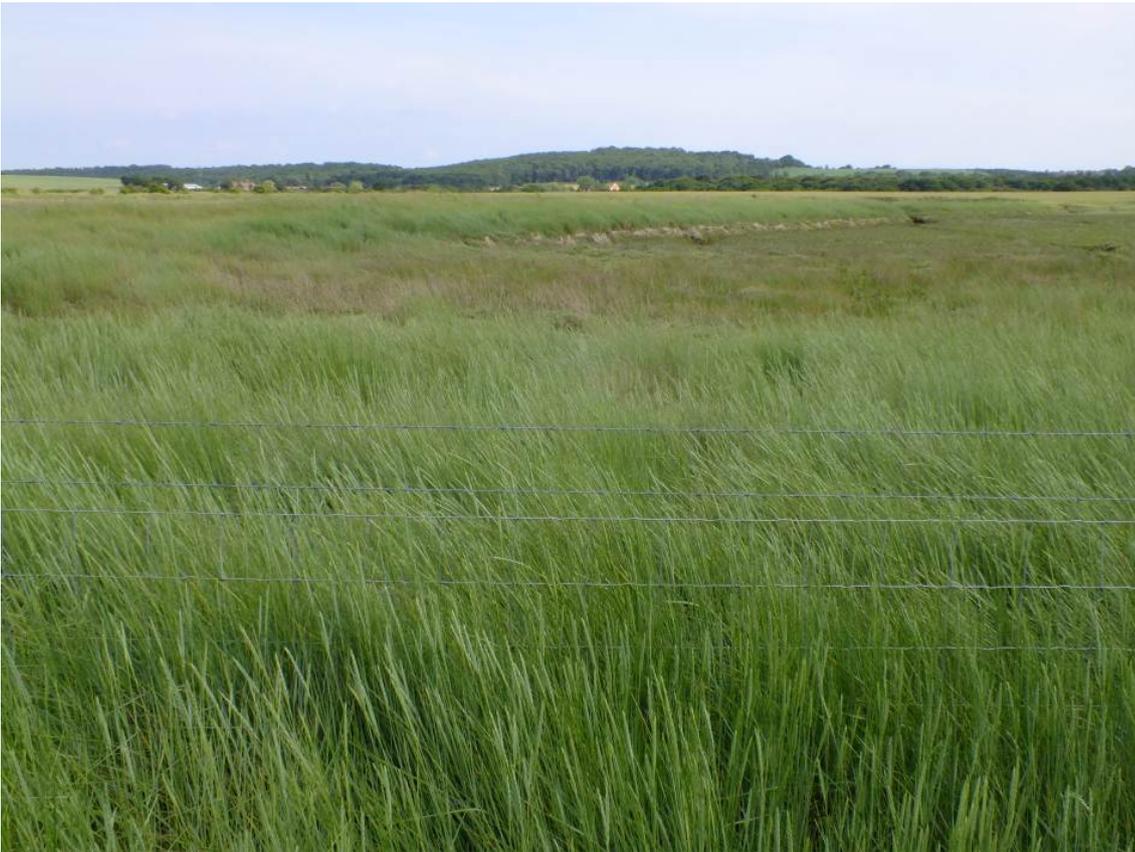
**Photo 6:** South part of Brandy Hole, viewed south-east from grid reference TQ83079533 across sea-couch zone to mid/upper saltmarsh, with old, breached seawall beyond (June 2015).

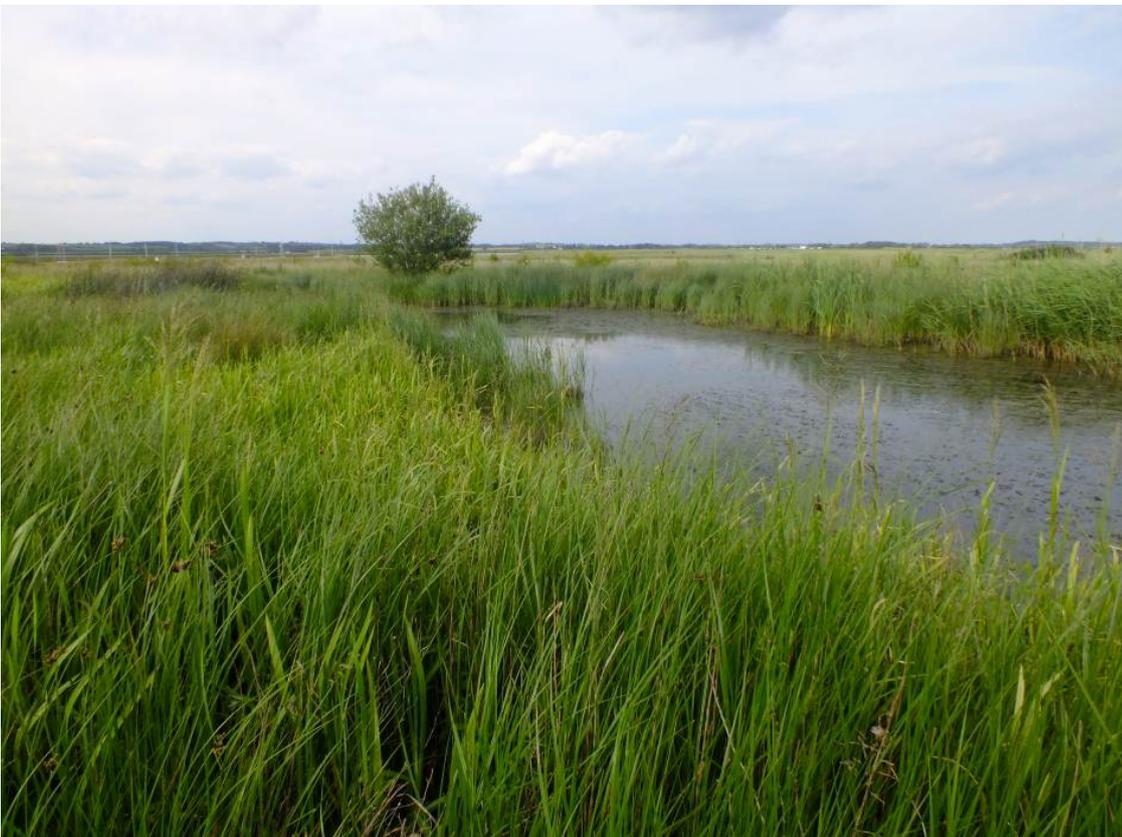
**Photo 7:** Pond on higher ground at Brandy Hole (grid reference TQ83089544) with sea and grey club-rushes, common reed, reed sweet-grass and other aquatic plants (June 2015).
